City of Round Rock

Stormwater Master Plan

Drainage Section
Volume 1

May 2014

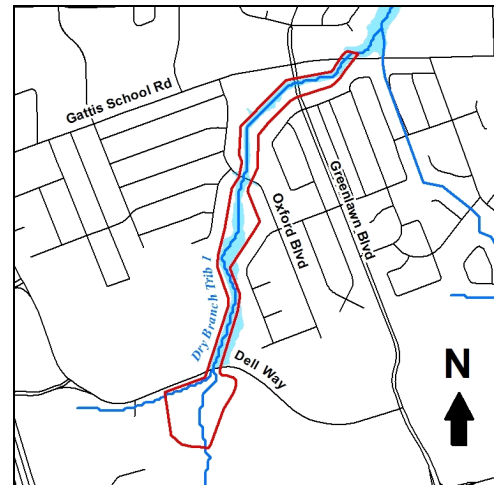
Reference Issues: **DB36, DB69, DB70**

Slope and sediment imbalance is causing deposition on the upstream section of Dry Branch Tributary 1 and scour on the downstream section. The concrete grade control structure upstream of Oxford Boulevard is undercut and has water flowing underneath the structure. The lower end of this structure is also cracked and slowly separating from the main body of the structure. Oxford Blvd. overtops 1.9' according to the Upper Brushy Creek WCID models which exceeds the 1' allowable criteria. Downstream of Oxford Blvd. to Greenlawn Blvd. there is scour on the left bank (looking downstream) and instability through the reach which could impact existing infrastructure on the left bank. Greenlawn Blvd. overtops at 0.6' which barely exceeds the 0.5' criteria. However, the overtopping contributes to the intersection flooding at the Gattis School Rd. and Greenlawn Blvd.

Additional storage at Dell Way Detention Basin could reduce the peak flow through Dry Branch Tributary 1. This increase in storage can come from either increasing the pond volume or decreasing the culvert size at Dell Way. If adequate detention is obtained the overtopping at Oxford Blvd. can be brought within the allowable limit of 1 ft and the overflow into the Gattis School Rd. and Greenlawn Blvd. intersection can be eliminated. The drop structure just upstream of Oxford Blvd. can be replaced with concrete, rock revetment mattress, or loose rock riffle. The rock revetment mattress and the loose rock riffle can provide additional energy dissipation and decrease erosional forces downstream. Construction of resistive bank stabilization on the left bank from Oxford Blvd. to Greenlawn Blvd. is needed to protect the existing infrastructure.

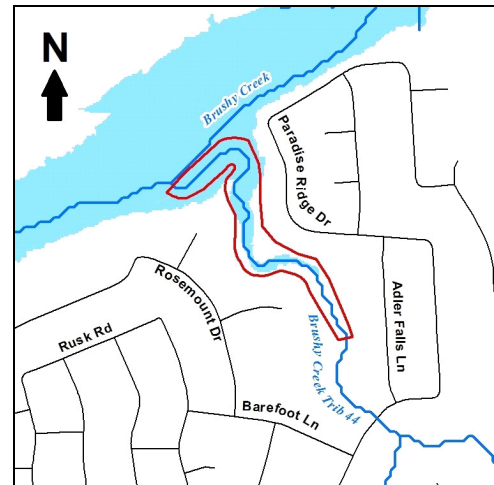
Reference Issues: **BC51**

Brushy Creek Tributary 44 experiences vertical bank scour approximately 10 feet tall on both sides of the channel as the tributary approaches Brushy Creek. The right bank is scoured back to the fence line of several homes on Paradise Ridge Drive. If this erosion continues to widen the right bank the homes will begin to lose property and fence lines. Mature hardwood trees on both sides of the eroded channel are at risk. These hardwood trees are most likely keeping the right bank stabilized. If these trees are undermined and lost the right bank erosion could accelerate and threaten the homes.

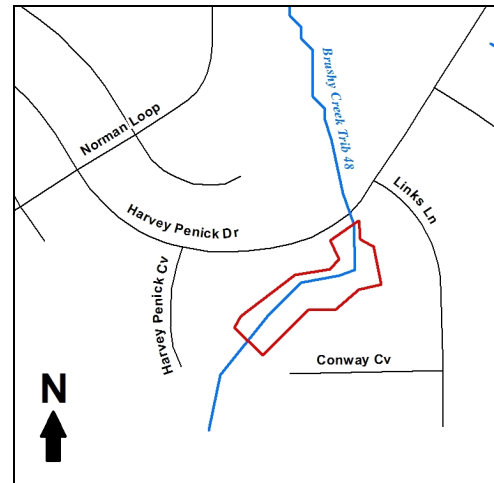
Reference Issues: **BC43**

Brushy Creek Tributary 48 takes a hard left turn (approximately 90 degrees) before going under Harvey Penick Rd. A drop structure just upstream of this turn has approximately 2 feet of downcutting under the downstream toe. An existing 8" wastewater line passes under this drop structure. Further downcutting could lead to undermining and putting this wastewater line at risk. The concrete toe along the outside bend (right bank) has been undercut over 2 feet. The erosion on the outside toe is beginning to undermine the concrete armoring. Erosion has started on the left inside bank which is not armored and is migrating towards Harvey Penick Dr.

Installation of resistive bank stabilization can protect the eroded right bank. Loose rock rip rap along the sloped right bank will protect the bank from further erosion. The rip rap will need to be toed into the channel in order to insure the rip rap remains in place. The left bank needs to be excavated in order to “round out” the bend to improve the transition angle of the turn. This will reduce the erosive forces on the inside (left) bank. Replacing the existing concrete grade control structure with rock riffle will reduce the velocity in the downstream problem reach. Reducing this velocity will decrease the erosive forces and help the rock rip rap armoring downstream. This rock riffle will also continue to protect the existing 8” wastewater line which crosses the channel in this location.

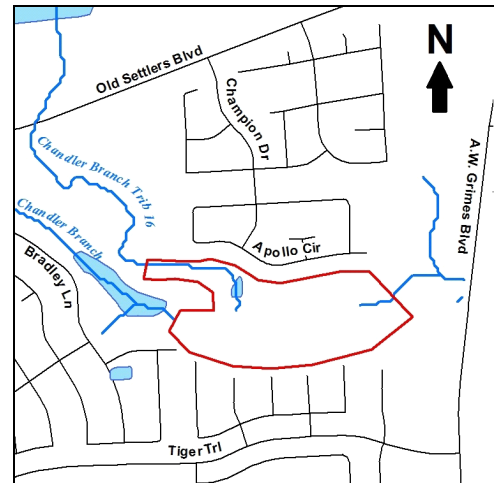
Reference Issues: **CB10**

Rock Hallow Park Pond is in line with Chandler Branch Tributary 16 and is just south of Rhodes subdivision. Historical flooding shows that the water surface from the pond has reached over 6 inches up the fence line along several homes directly to the east of the pond. The right embankment of the pond is only slightly higher than the outfall weir of the pond resulting in frequent spilling to the east towards the homes. The pond outfalls into Chandler Branch mainstem which is choked by dense vegetation both upstream and downstream of the outfall. Additional 2-D hydraulic modeling has shown that Chandler Branch backflows into the pond which increases the severity of spilling from the pond to the east.

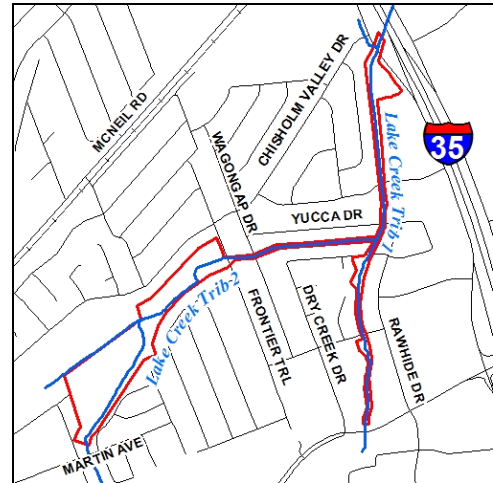
Reference Issues: **LC59-LC64**

Lake Creek Tributary 1 and Tributary 2 run through the Chisholm Valley subdivision. The current WCID models indicate that approximately 98 structures are at risk during the 100-yr storm event along these two reaches. The current models also indicate that 6 roadway crossings exceed the City of Round Rock overtopping criteria for the 100-yr storm event. However, these models do not account for the existing detention at Purple Sage Dr. and at the IH-35 southbound frontage road. The detention outlet structure at Purple Sage Drive is also undersized and causes several structures to be inundated upstream.

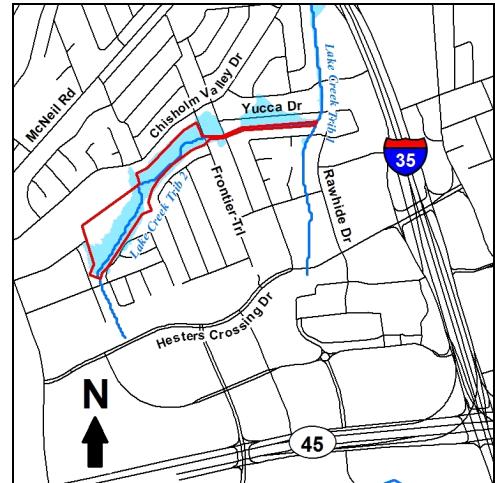
Reference Issues: **LC59, LC60, LC61**

Large mature trees within existing engineered drainage ditch in Lake Creek Tributary 2 between Yucca Dr. and Purple Sage Dr. are “choking” the channel causing a potential increase in the water surface elevation. The capacity of this engineered channel downstream of Wagon Gap Drive is inadequate causing spilling during the 100-yr event between 603 Yucca Drive and 505 Yucca Drive, which inundates 8 homes. This spilling can possibly contribute to additional flooding issues down Yucca Drive. Frontier Trail is overtopped by 0.65 ft exceeding the allowable limit of 6 inches for a nonresidential road during the 100-yr event. Wagon Gap Drive is also overtopped by 0.6 ft during the 100-yr event although it meets the allowable limit of 1 ft.

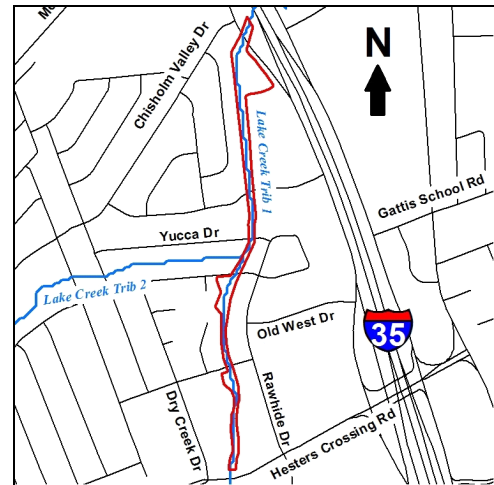
Reference Issues: LC62, LC63, LC64, LC80, LC81

Lake Creek Tributary 1 experiences several issues beginning at Hester's Crossing and ending at the southbound service road of IH-35. The WCID model indicates that the Purple Sage Rd., Yucca Dr., Buckboard Blvd., and IH-35 southbound service road are all overtop by more than 1 ft in the 100-year ultimate storm. The detention pond upstream of Purple Sage Dr. is undersized, and WCID models show that Purple Sage Dr. overtops during the 25-yr event. The WCID model also indicates that over 50 structures are at risk during the 100-yr event along this reach. Just downstream of Yucca Dr. a concrete drop structure is cracked and undermined. The multiple box culverts at the IH-35 southbound frontage road are much wider than the approaching channel, and the outside culverts are showing evidence of siltation. It appears that there is a significant headloss at this expansion point. Additionally, the WCID hydrologic model does not appear to account for the storage at the frontage road and at Purple Sage Dr.

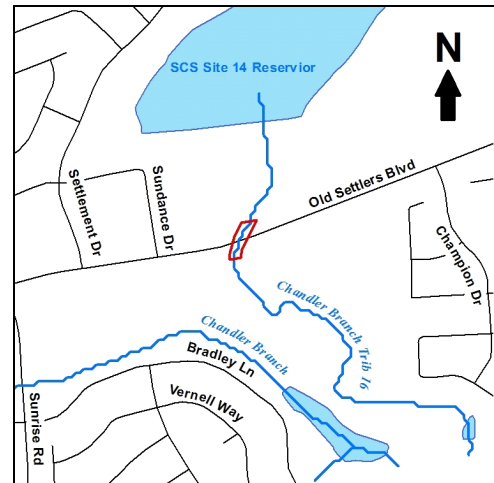
Reference Issues: **CB11**

Chandler Branch Tributary 16 passes under Old Settlers Blvd. through a 66" RCP. At the upstream headwall of Old Settlers Blvd, a 42" stormwater RCP discharges in the upstream direction, which causes a large amount of head loss and conveyance issues. On the downstream side of Old Settlers Blvd a 60" RCP coming from the west and a 30" RCP coming from the east join with the 66" RCP (under Old Settlers Blvd) and form 3 outlets at the downstream headwall. The grade just downstream of Old Settlers is flat which causes a large amount of sediment buildup on the downstream side of the culvert crossing. The sediment accumulation could also be caused by low velocities through the culvert caused by the head loss from the upstream (42" RCP). This sediment buildup is clogging 50% of all three of the outlet pipes (66", 60", and 30" RCPs) which could cause Old Settlers Blvd to overtop and the inlets of the stormwater pipes to operate inefficiently during a major event.

Modification of the existing culvert system can reduce the head loss caused by the 42" RCP stormwater outfall discharging at an upstream angle. Replacement of the 66" culvert with a 6' x 6' box culvert will allow the 42" stormwater outfall to tie in under Old Settler Blvd and discharge at a downstream angle. The two other stormwater outfalls (60" and 30" RCPs) could also tie in under the roadway in order to create a single culvert outlet on the downstream side of Old Settlers Blvd. Allowing these stormwater outfalls to discharge at downstream angles will decrease head loss and increase velocities allowing the sediment to move further downstream. Construction of a sloped concrete apron on the downstream side of the culvert will further reduce the sediment buildup and erosive forces.

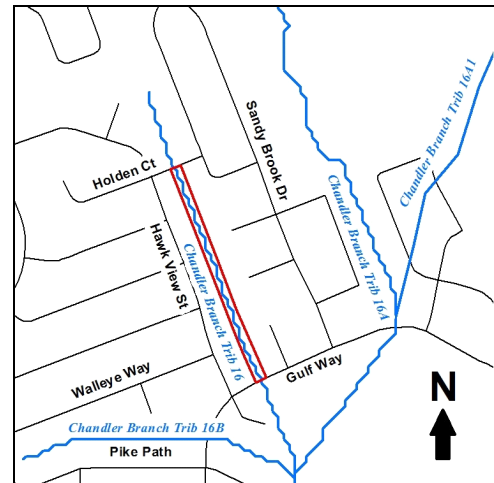
Reference Issues: **CB19**

This 2,400 foot reach is an engineered linear earthen channel with a concrete pilot channel and a slope of 0.8 percent. The earthen channel is subject to intermittent erosion as the water depth gets just higher than the concrete pilot channel. The erosion patterns appear to meander from side to side of the concrete channel. The vegetation on the east side of the channel (gets direct sunlight from the south and west) has not taken hold and the earthen channel is bare. Toward the north end of the reach (toward Holden Dr.) the concrete pilot channel moves toward the west side of the channel leaving the slope of the earthen ditch bank with a steep slope. The wooden privacy fences in this short reach are being undercut and impacted. A water quality basin exists on the west side about half way along the channel. The outlet is regulated with rock rip rap with the outflow moving under the existing wooden fence. The earthen channel is not armored and about two feet of scour has occurred (partially endangering an existing power pole).

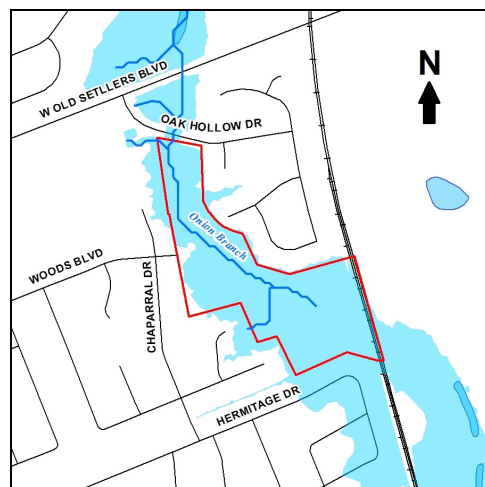
Reference Issues: **OB29**

Onion Branch passes between Oak Hollow and The Woods subdivisions then goes under a Union Pacific Railroad through four 8' x 4' box culverts. There is an existing concrete detention structure just upstream of the railroad crossing. A depression just upstream of the detention structure causes water to pond. This stagnant water contributes to water quality (odor) issues and can provide a breeding ground for mosquitos and other bugs. Additionally, the baffle blocks on the existing detention structure are dense and form a "trash rack" that collects debris and needs frequent maintenance.

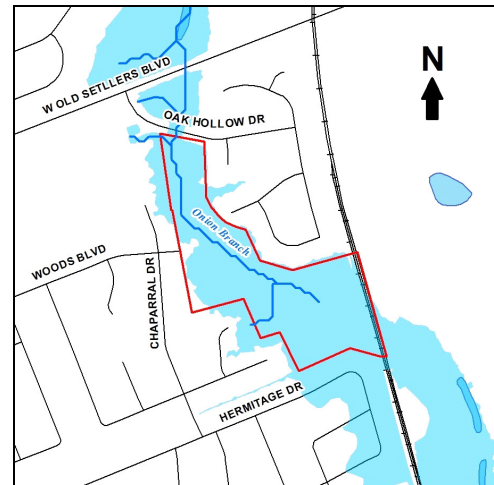
Reference Issues: **OB29**

Onion Branch passes between Oak Hollow and The Woods subdivisions then goes under a Union Pacific Railroad through four 8' x 4' box culverts. There is an existing concrete detention structure just upstream of the railroad crossing. The railroad crossing is overtopped 2.9 feet in the 25-year event and 3.4 feet in the 100-year event according to the WCID ultimate condition models. The backwater from the railroad creates a very flat floodplain slope (essentially a lake) extending upstream to Old Settlers Blvd. It appears that approximately 10 homes (in the Hermitage Drive area) would become surrounded (or have their access significantly impacted) by the backwater from this railroad trestle overtopping.

Addition of culverts to the railroad crossing can reduce the 25-year WSEL to a degree that the residential roadways would be more passable and the affected homes would be more accessible. Additional concrete pipes could be “jack and bored” through the embankment. The weir flow over the trestle in the 25-year ultimate condition is around 320 cfs. An additional three 48” diameter pipes would help achieve this reduction.

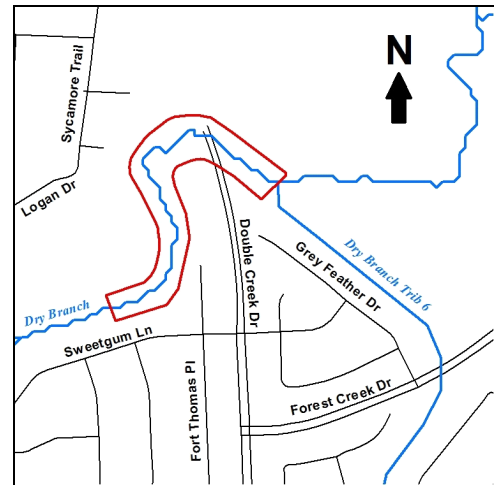
Reference Issues: **DB31**

This 1700' reach is upstream of the existing railroad trestle located where Double Creek Drive would cross Dry Branch if it were extended. In this reach Dry Branch makes several meander bends each displaying significant bank scour. Several 100 feet of vertical scour with bank heights as much as 10' were observed. WCID hydraulic models indicate velocities upward of 14 fps and water depths of 17 feet in the 100-year event. Unchecked, these meanders may put the homes on Tenanza Cove and Sycamore Trail at risk. The eroded vertical bank is approximately 50' from the fence line of these homes. The land adjacent to this reach is undeveloped open space natural parkland. Although no trails or infrastructure exist in this park, unchecked bank scour certainly diminishes the use of this parkland and might add some risk to the patrons.

Installment of longitudinal fill stone toe protection will help protect the outside curves of the meander from encroaching further on the homes along Tenaza Cove and Sycamore Trail. A “pyramid” of larger loose rock approximately 10 feet away from the existing toe will help resist erosive forces. The area behind the toe will be filled in with soil creating a gentler slope, armored with traditional Turf Reinforcement Mat (TRM), and revegetated. This technique will reclaim some of the eroded bank would not require removal of any large trees. Placement of rock riffle grade control structures downstream and along the erosive area will provide additional energy dissipation. The grade control structures will increase the tailwater elevation and thereby reduce the stream “power” in the problem reach by reducing the slope

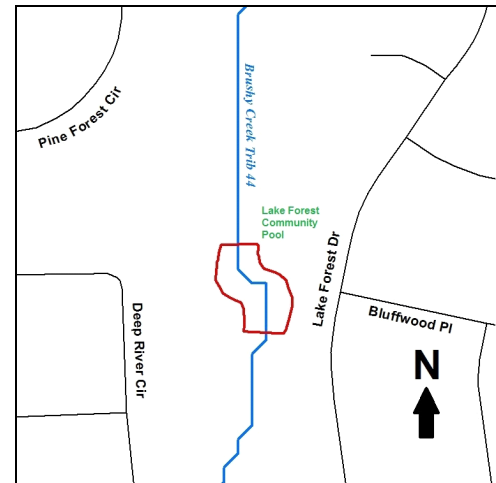
Reference Issues: **BC48**

A section of Brush Creek Tributary 44 parallels Lake Forest Drive for from Fernspring Drive to Bluffwood Drive. The channel bottom throughout this stretch has a bedrock bottom which creates high velocities in the channel. At the Lake Forest Community Pool, Brushy Creek Tributary 44 enters an S-curve with two approximately 90 degree bends. On the eastern slope of the first bend is a denuded slope with a metal fence on the top of the bank. The scoured slope is nearing the fence and will eventually undermine the fence. This bank also receives western sunlight and cannot support vegetation. The second bend forms a steep bank on the left bank (west). The vertical bank height approaches 10 feet and continued erosion will put several mature trees at risk of falling into the channel bottom.

The denuded banks of both bends are in need of resistive bank stabilization to prevent further erosion. Longitudinal fill stone protection (LFSTP) is a “pyramid” of larger loose rocks which will be located 5 to 10 feet from the existing toe. The area behind this longitudinal toe will be filled with soil, reclaiming some of the eroded slope. The resulting slope will be gentler and protected with traditional Turf Reinforcement Mat (TRM) and vegetated. The use of LFSTP will work around existing trees and provide soil that can be revegetated. A soil amendment to the first bend (western) which can include compost or fungi to create a proper “fungi to bacteria ratio” will help with moisture retention and allow vegetation to establish without temporary irrigation.

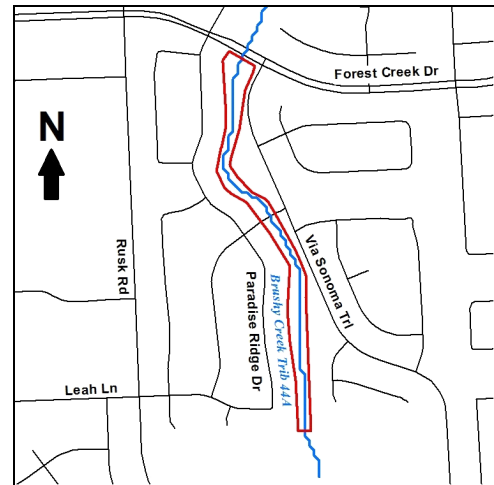
Reference Issues: **BC49**

This 2,400' reach parallels Via Sonoma Trail and extends from Leah Lane (southern end) downstream to Forest Creek Drive (northern end). The majority of the channel reach has scoured down to rock. Due to the increased velocity along the rock, the interface with the adjoining bank material is intermittently about one foot in height. Street drainage from Via Sonoma Trail is released into the tributary onto the right (eastern) bank. Although energy dissipation is provided at this headwall, the union with the channel flow has created a plunge pool. Plunge pools are nature's way of creating an energy dissipation feature. The problem at the plunge pool is that the rock-soil interface is being attacked and the banks have been cut roughly six feet deep.

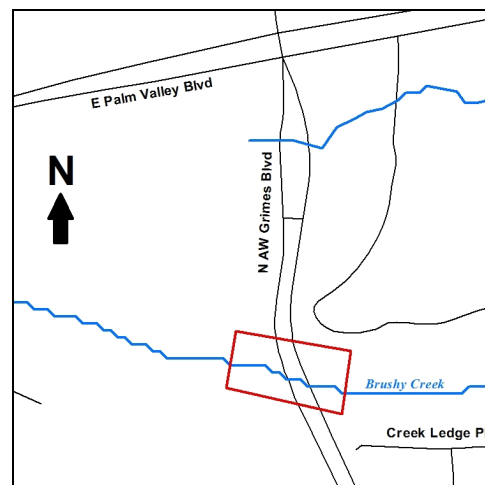
Reference Issues: **BC54**

High velocities through Brushy Creek are scouring the bridge piers at A.W. Grimes Boulevard. There is no riparian vegetation along the creek banks or in the overbanks underneath the bridge leaving the bare soil susceptible to erosive forces. Additionally, a 24 in storm sewer pipe outfalls on the right (south) bank and is eroding around the adjacent piers to a depth of three to four feet. This storm outfall is also causing a plunge pool to form near the adjacent piers which is accelerating the bank scour. The continued erosion at the bridge piers could lead to foundational problems for the bridge crossing.

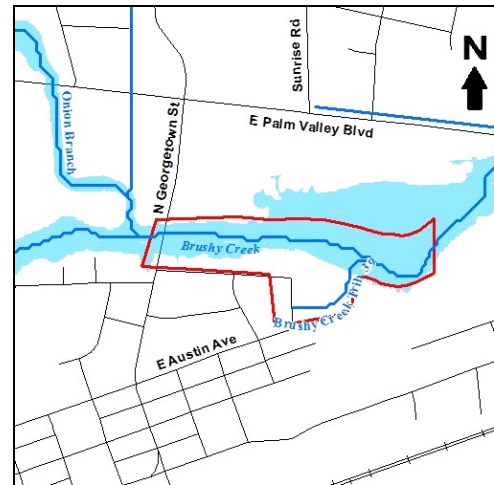
Reference Issues: **BC56**

Just downstream of Georgetown St., Brushy Creek parallels the south side of Palm Valley Blvd. and Brushy Creek Dr. Just downstream of Georgetown St. the right bank of Brushy Creek is experiencing severe bank erosion. Many of the residents along Brushy Creek Drive are losing property and fences due to the encroaching bank. Observations from the 10/31/13 flood event show that flow from the tributary upstream of Georgetown St. is pushing against the right bank and causing the vertical bank erosion. Brushy Creek Tributary 39 passes through a residential and drains into Brushy Creek further downstream. An 8' wide shallow local drainage flume had been developed between two homes composed of railroad timbers as vertical sidewalls. Over time silt has been deposited in that open channel such that it only has one foot of depth before it overflows into the adjacent residential lots. The WCID hydraulic models identify 30 structures as being a risk during the 100-yr storm event.

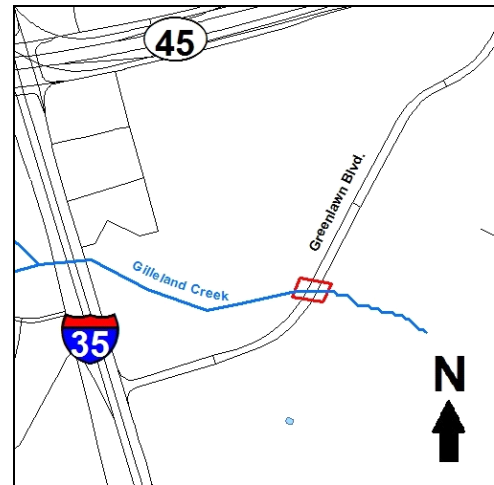
Reference Issues: **GC83**

This 500' reach encompasses the Greenlawn Boulevard road crossing of Gilleland Creek just east of IH-35. Greenlawn Boulevard is a four lane major arterial roadway. The existing structure has six box culverts. Three of the six boxes (outside ends) have accumulated sediment which restricts their flow carrying capacity. The Gilleland 2009 LOMR (09-06-1966P-481026) indicates Greenlawn Blvd. overtops 4.2' in the 100-year ultimate condition event. The multiple box culverts at Greenlawn Blvd. are much wider than the approaching channel. It appears that there is a headloss at this expansion point. Greenlawn Boulevard has a "sag" or low point in the roadway just north of the Gilleland Creek crossing. Site observations after the October 31, 2013 flood indicated an overflow from the left side of the upstream (west) headwall diagonally across all lanes of the roadway and then exiting the eastern right-of-way near the sag inlet. This overflow created a deep pool causing the roadway to be closed during the flood
